KOLPAK[®]
A Welbilt Brand

Door Icing

Door Components

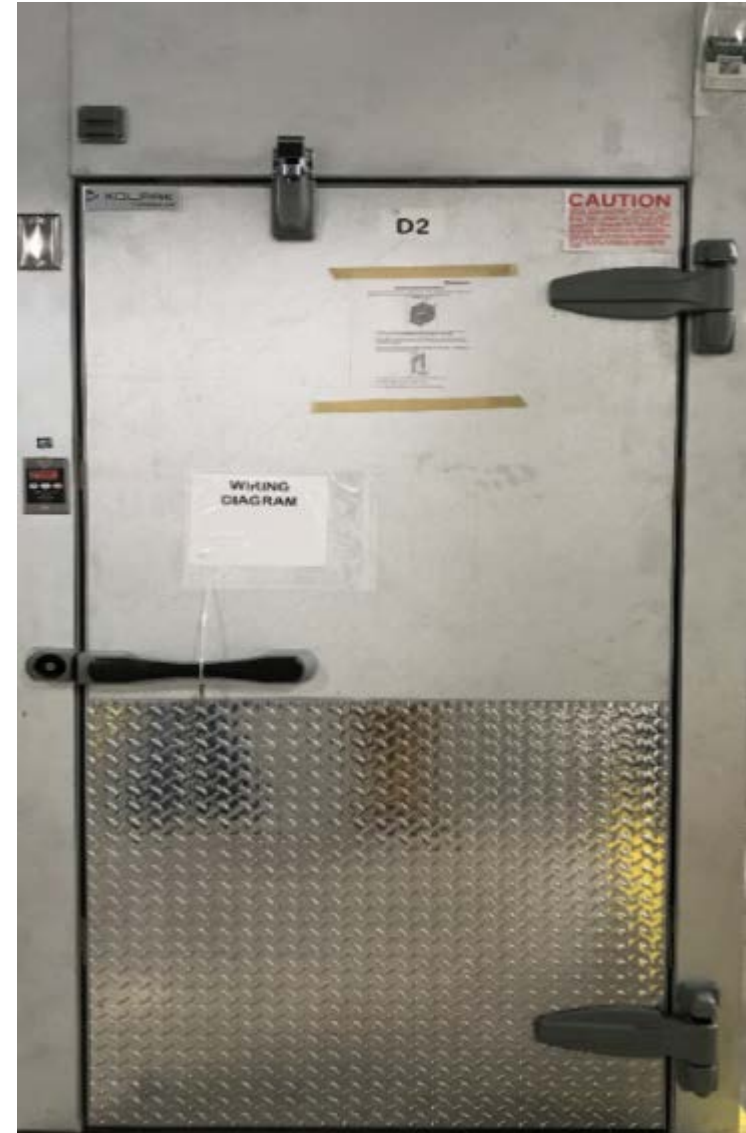
Door hardware prevents door icing

- Door Frame Heater
- Door Closer
- Door Gasket
- Door Sweep
- Door Hinges
- Pressure Relief Vent
- Strip Curtains/Clear-Vu Doors

If any one component fails, it can contribute to excessive door icing.

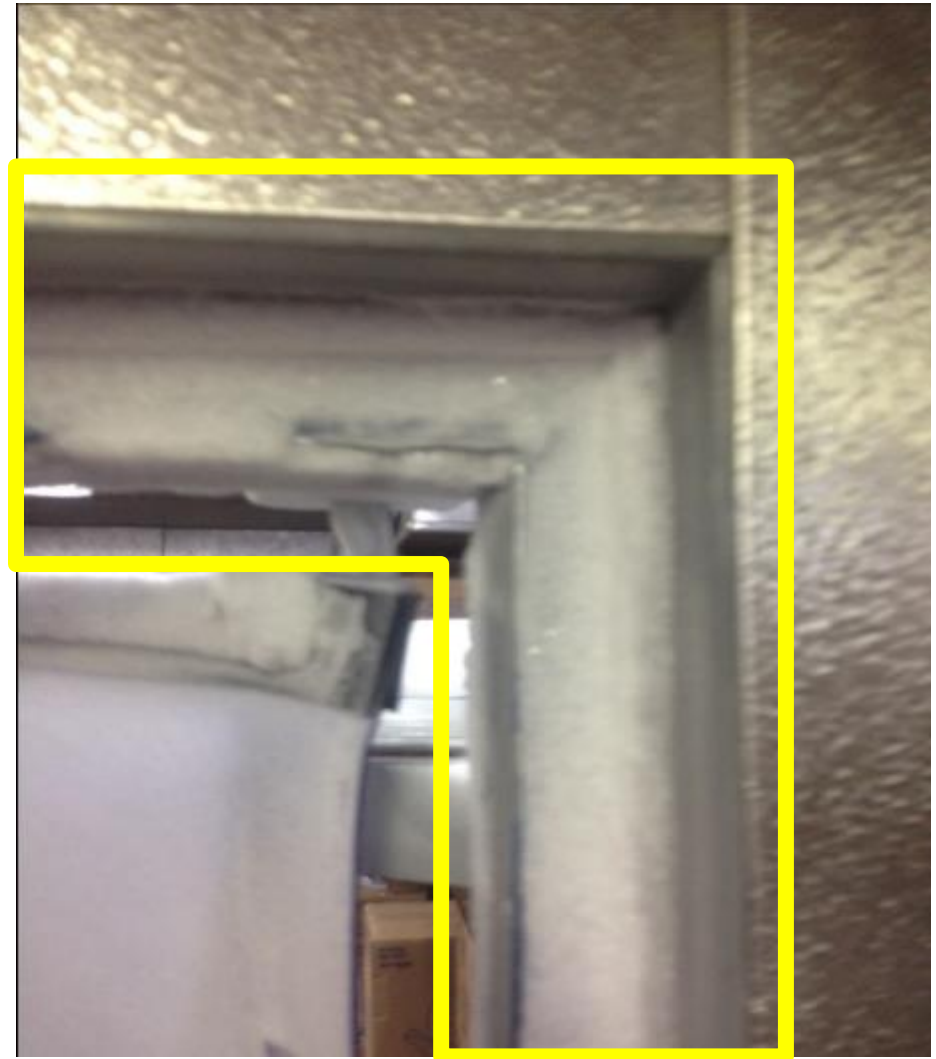
Door Frame Heater

- 115 Volts
- 2.5 watts per foot (standard DOE)
 - .4 -.5 amps
 - 265 OHMS
- 5 watts per foot
 - .8 -.9 amps
 - 155 OHMS
- Heater trim should be free and clear of ice.
- Do not base heater failure on feel/touch.
- An amp draw or resistance reading must be taken to confirm operation.

If the heater specifications do not fall within these parameters, it is an indication the heater could be faulty.

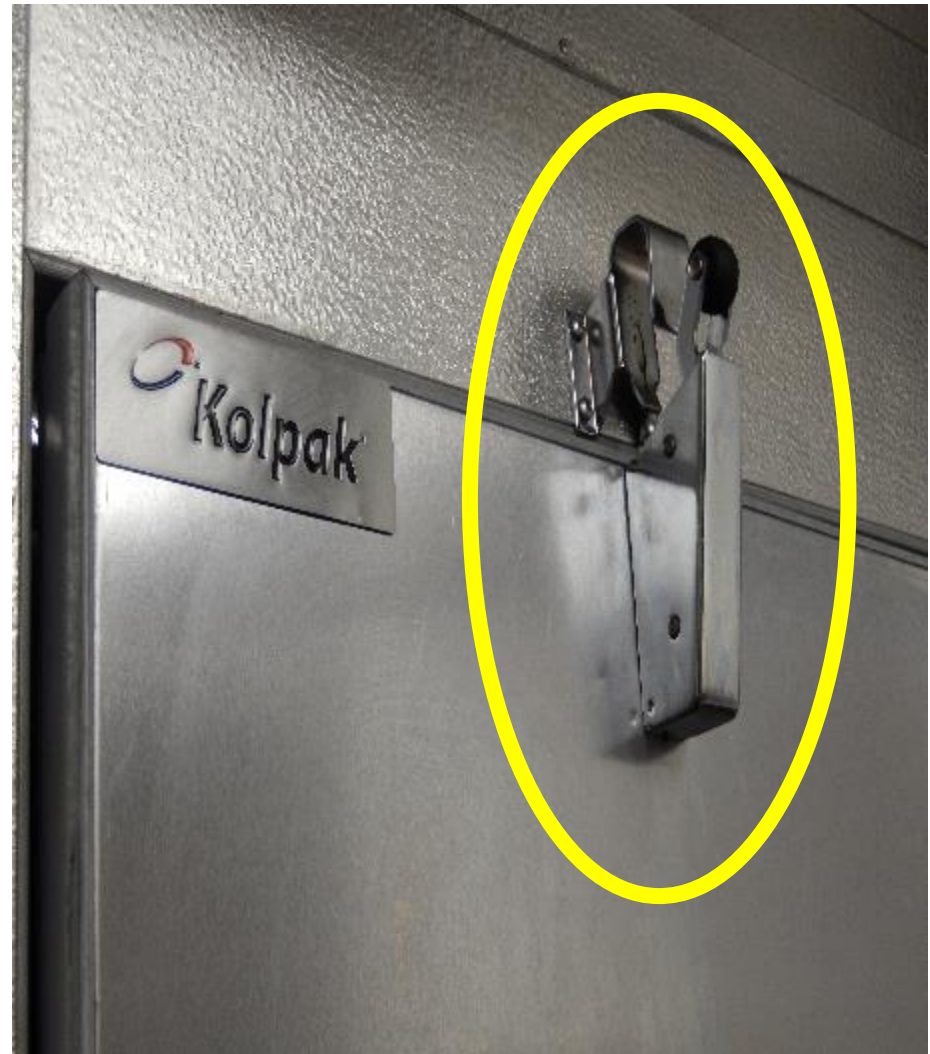
Door Closer

- Weak spring.
- Weak hydraulic mechanism.
- Out of adjustment.
- Prevents door from closing, not allowing proper seal.
 - Allows infiltration around door creating excessive ice.

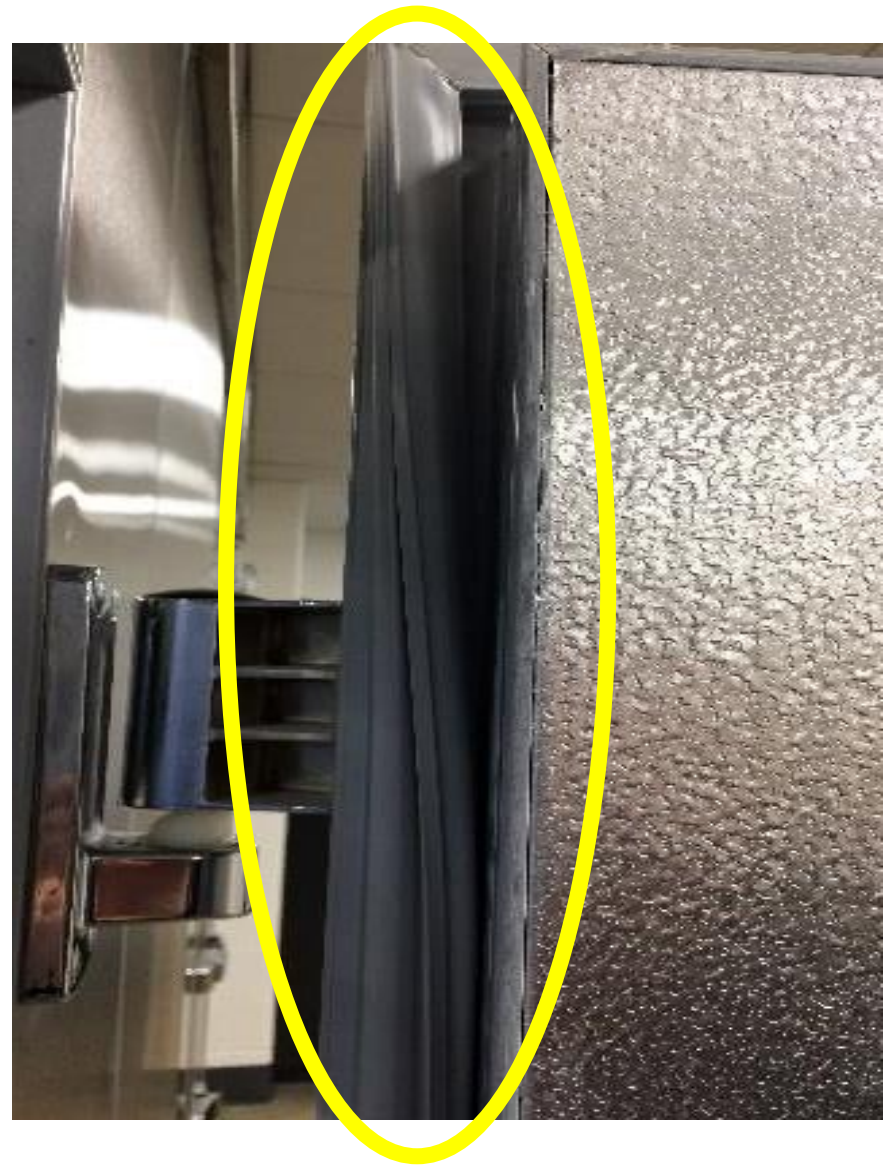
Door Gasket

Gasket is Rolled or Torn

- Check operation of door, should open and close freely without assistance.
- Ensure gasket is sealing around entire door parameter.
 - Dollar Bill Resistance Test.
- Replace gasket.
 - Adjust frame/door if necessary.
 - Shim hinges to allow proper seal/clearance.

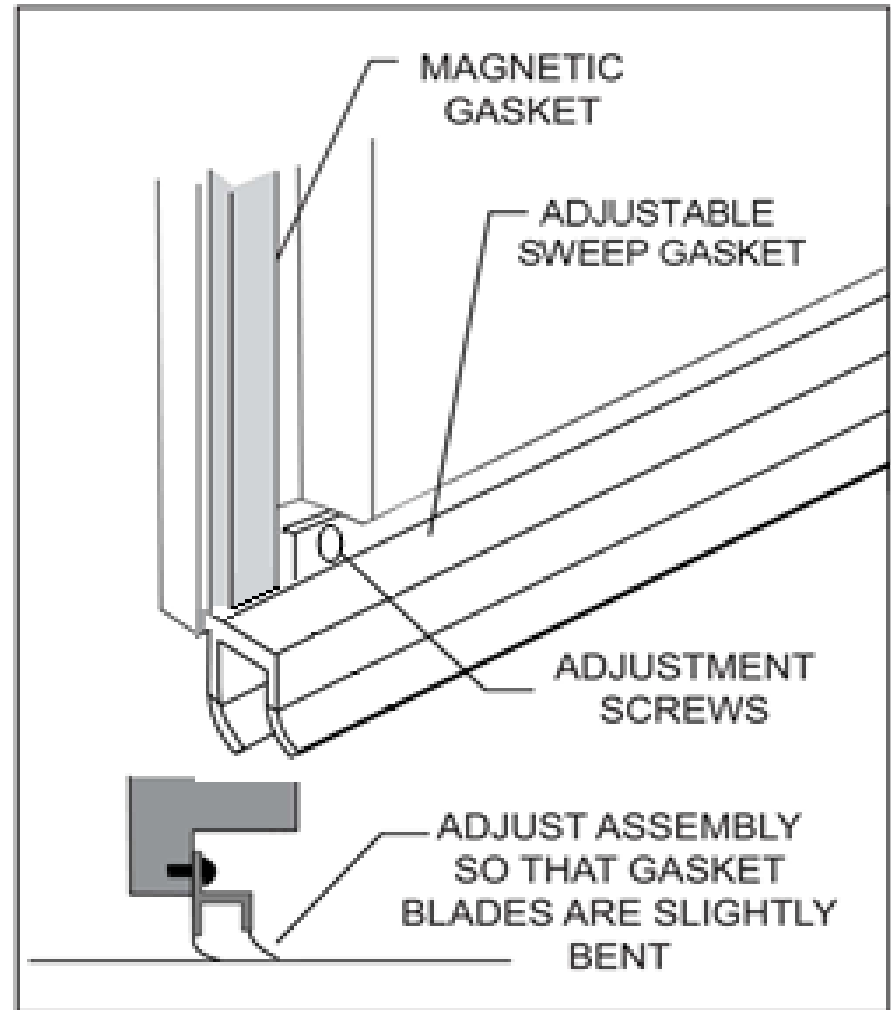
Door Sweep Adjustment

- Adjust door sweep to lightly contact floor/threshold.
- Seal gap between bottom of the door gasket and the top of the door sweep if adjusted down.

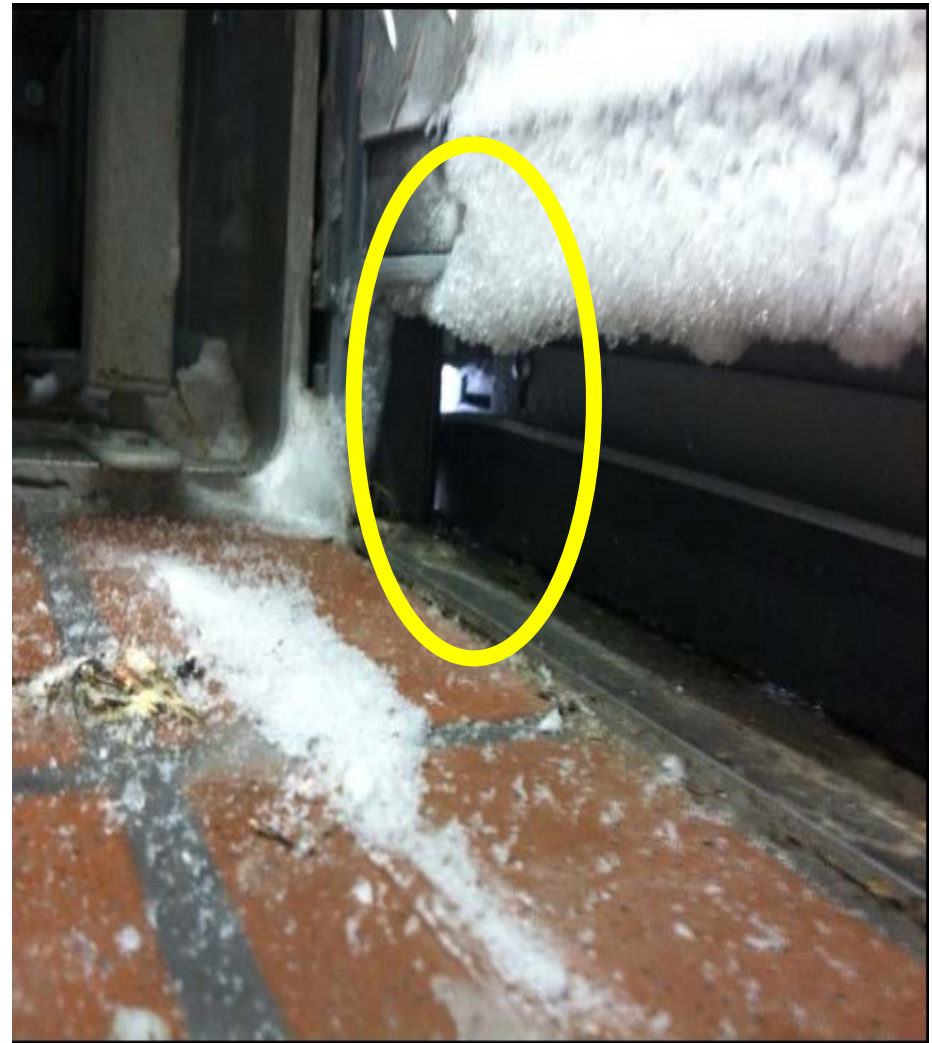
Door Sweep

Air gap beneath door

- Occurs when sweep is adjusted down.
- Allows air infiltration, causing excessive ice/frost accumulation.
- Gap needs to be filled with approved sealant.

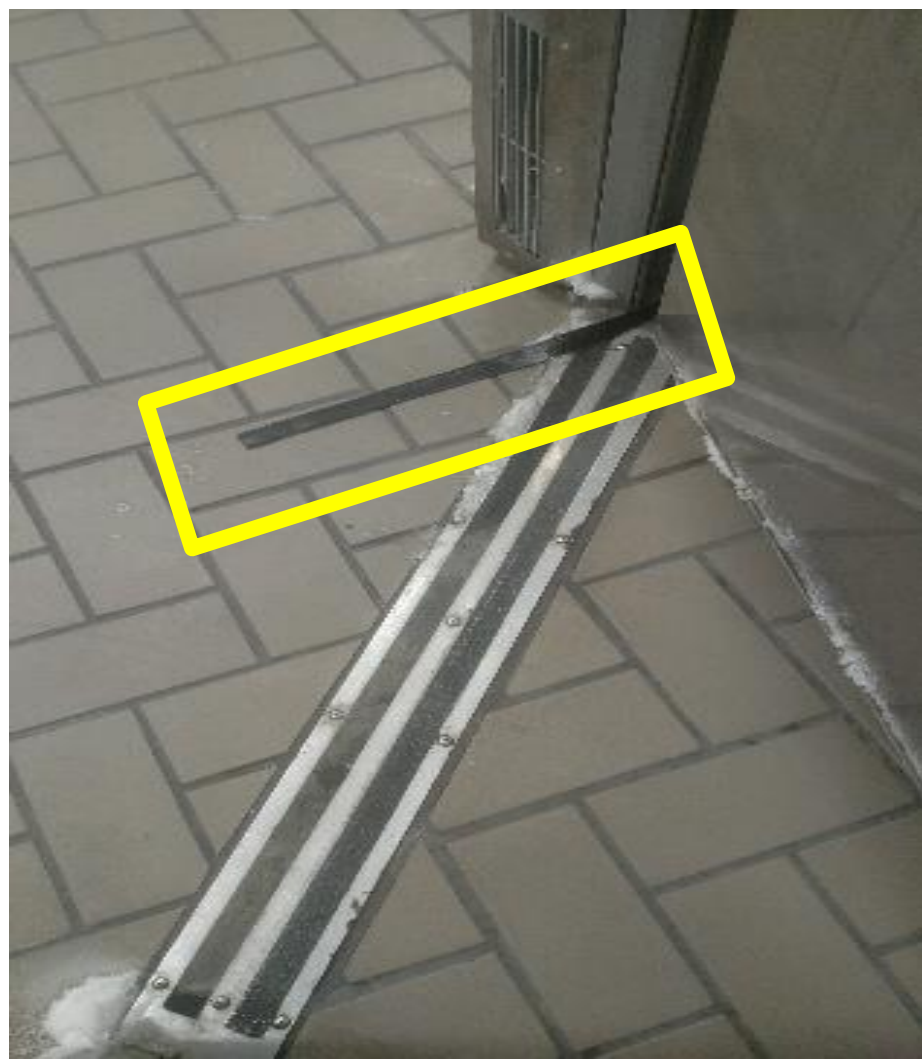
Door Sweep

Door sweep missing or torn.

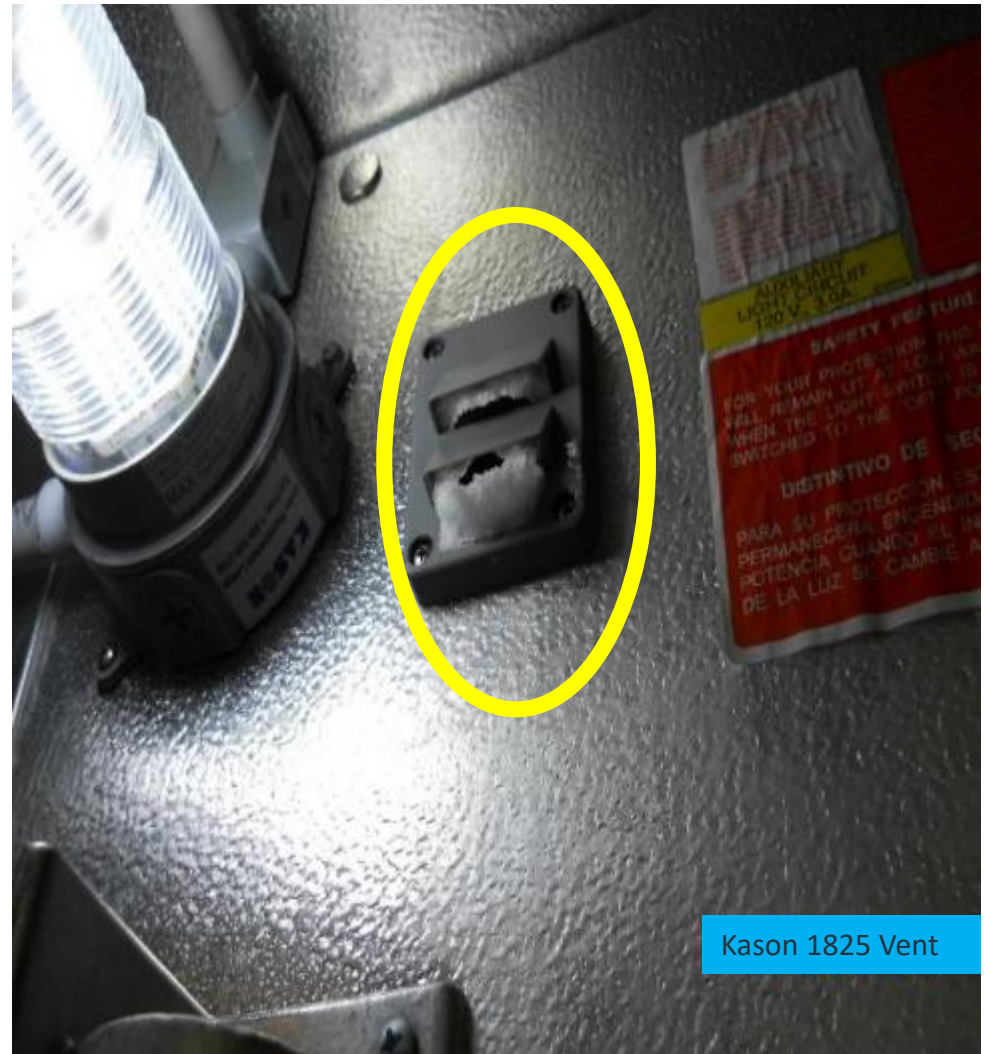
Pressure Relief Vent

Vent iced up not allowing air to enter walk-in.

- Vent Heater is defective
- Cylinder is froze in open position
- Cylinder is froze in closed position

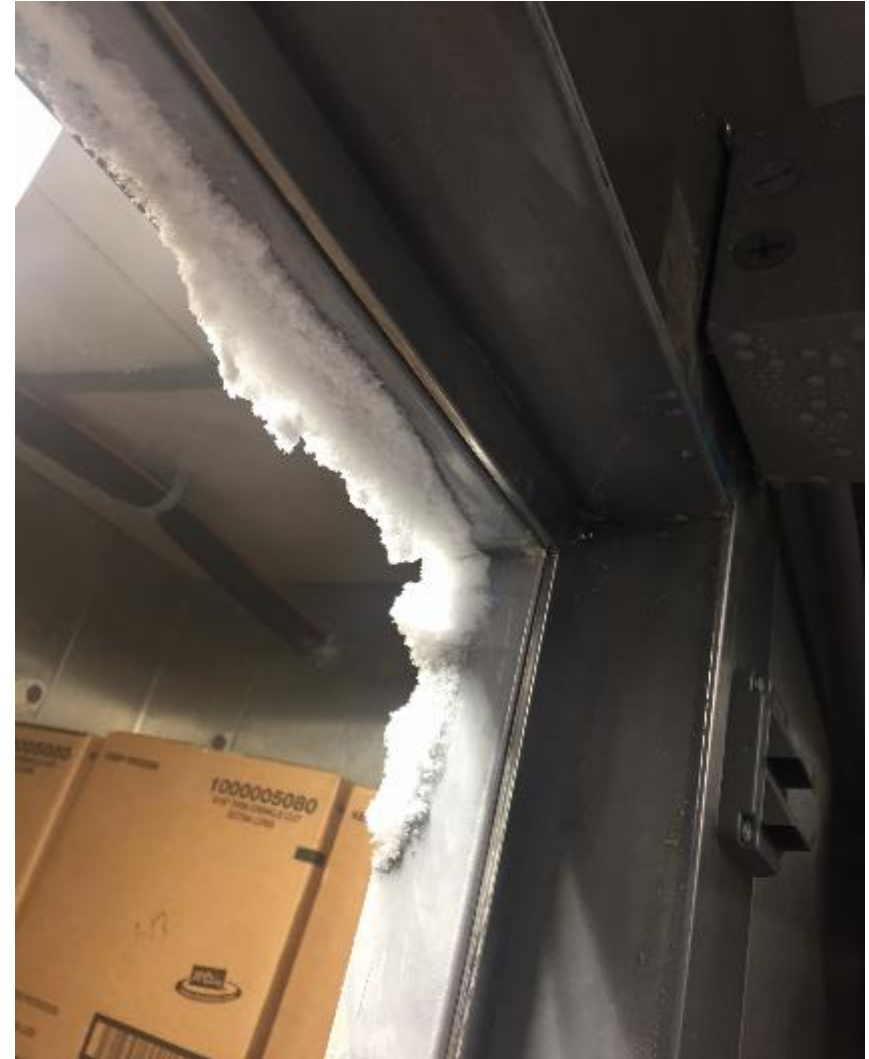
Pressure Relief Vent

When interior pressure cannot equalize.

- Outside air will be pulled in around the door gasket
- Outside air will be pulled in around the door sweep

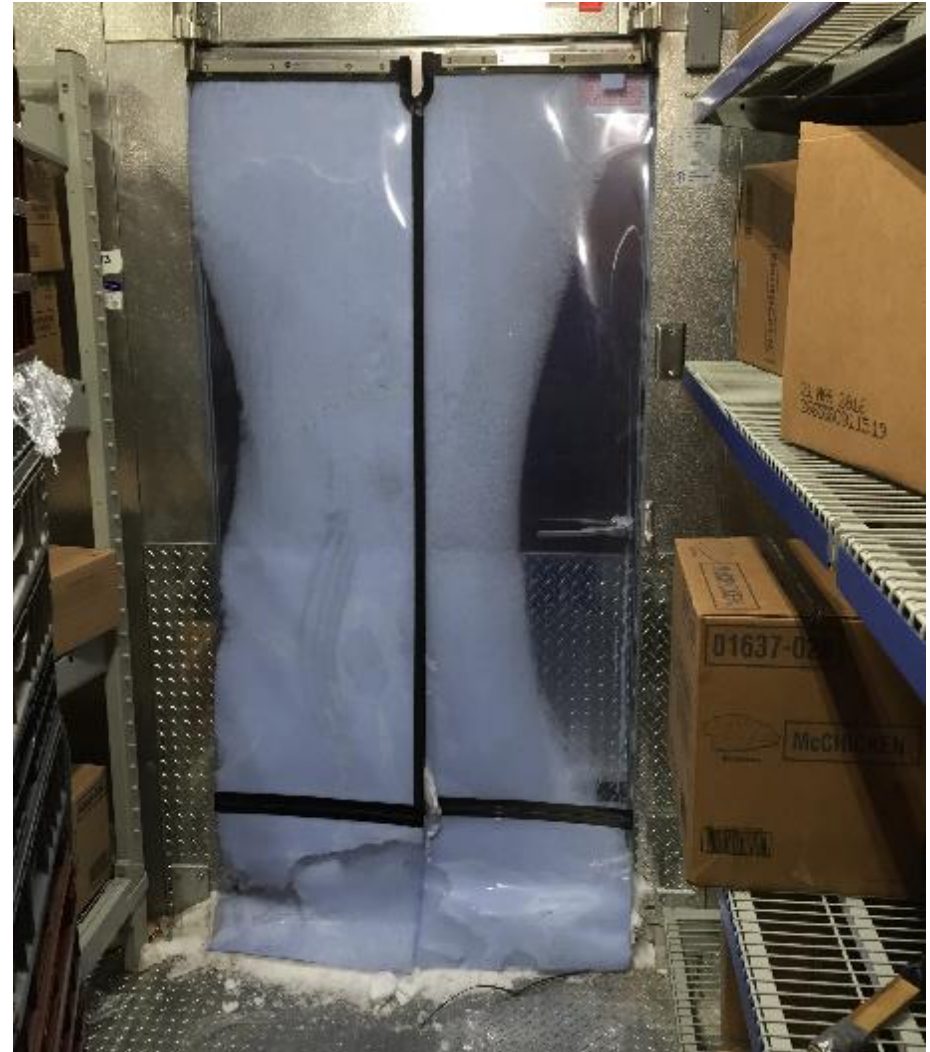
Strip Curtains/Clear-Vu Doors

- Reduce Moisture infiltration
- Incorrect length
 - 1/2" -1" off floor
- Require maintenance as
- Ice accumulation can prevent man door from closing, contributing to additional icing.

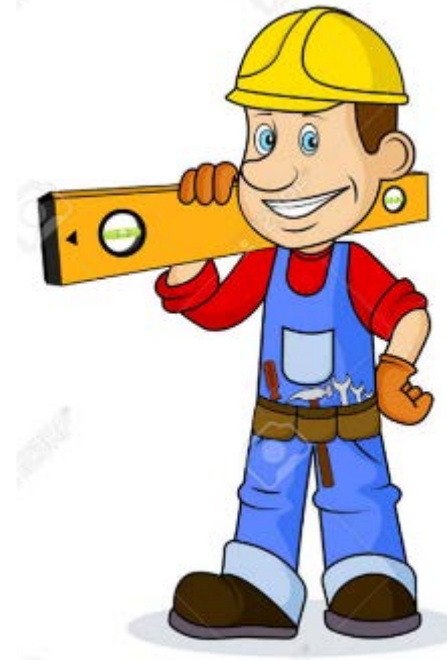
Install/End User

- Install
 - Door frame out of square
 - Floor not level
 - Hinges need adjusting
- End User
 - Door left open or propped open
 - Too much product inside freezer

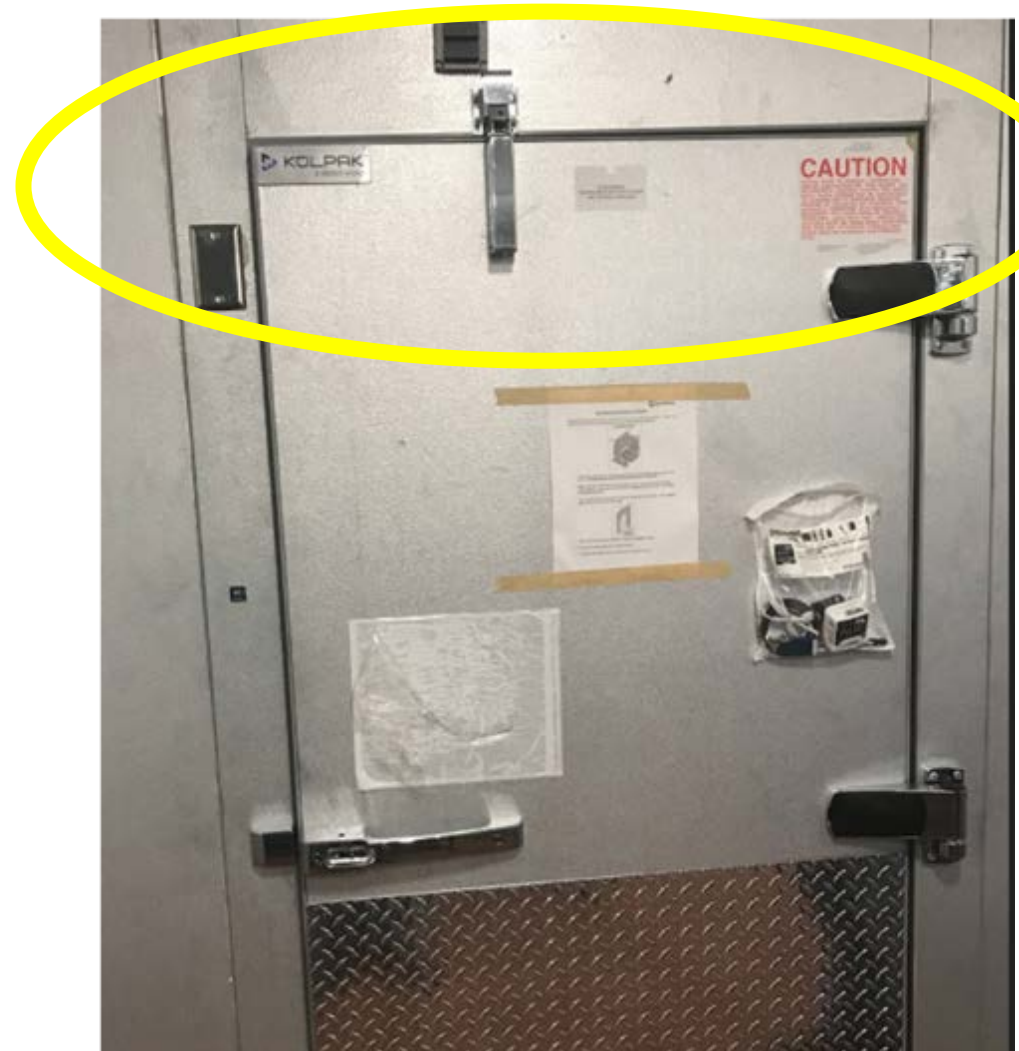
Door Frame Not Squared

- Floor not level.
- Door section not installed properly.

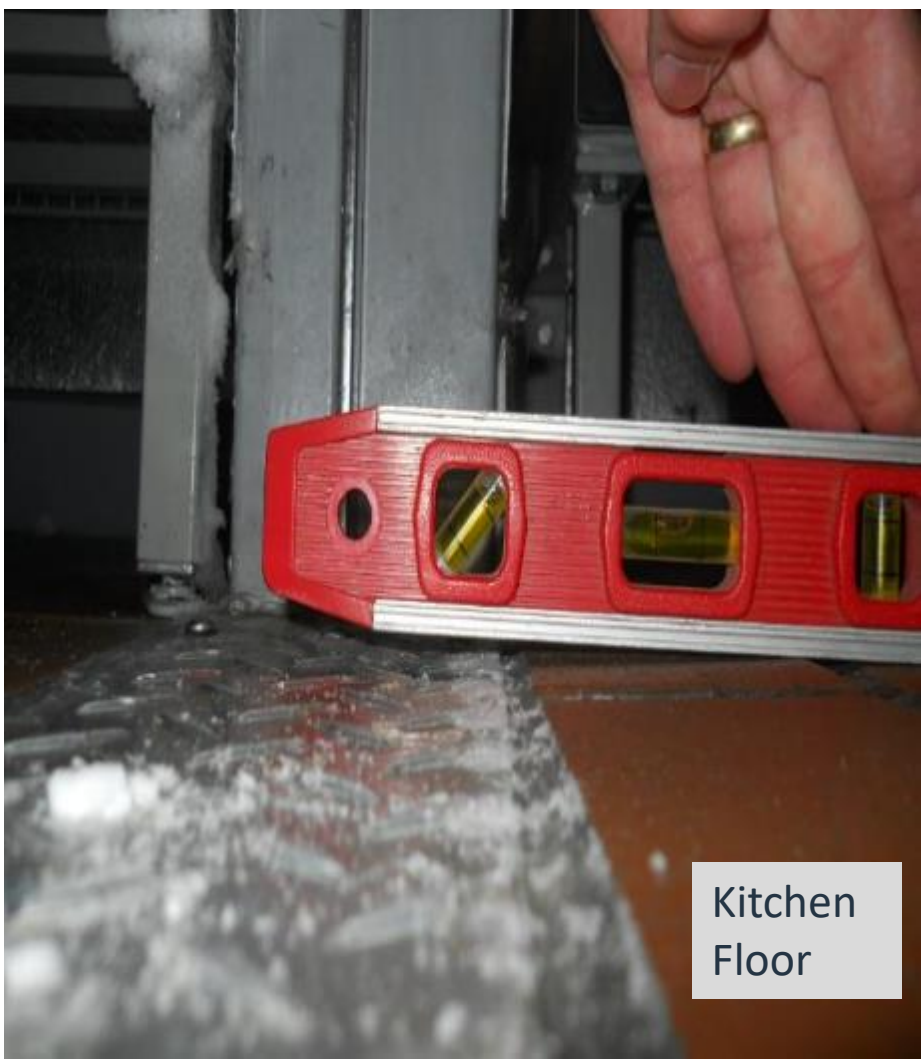
Un-level Floor

- Door may not close properly if exterior surface is higher than walk-in floor.
- Sweep damage

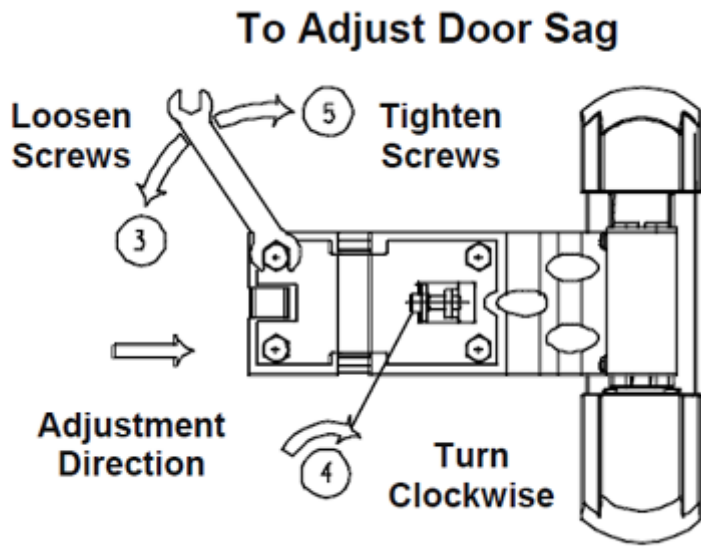
Hinge Adjustment

Doors may need to be adjusted at install to accommodate site conditions.

Example: Door frame out of square, Floor un-level, etc.,

Some hinges have adjustment for these conditions.

- Kason 1345
- Kason 1346

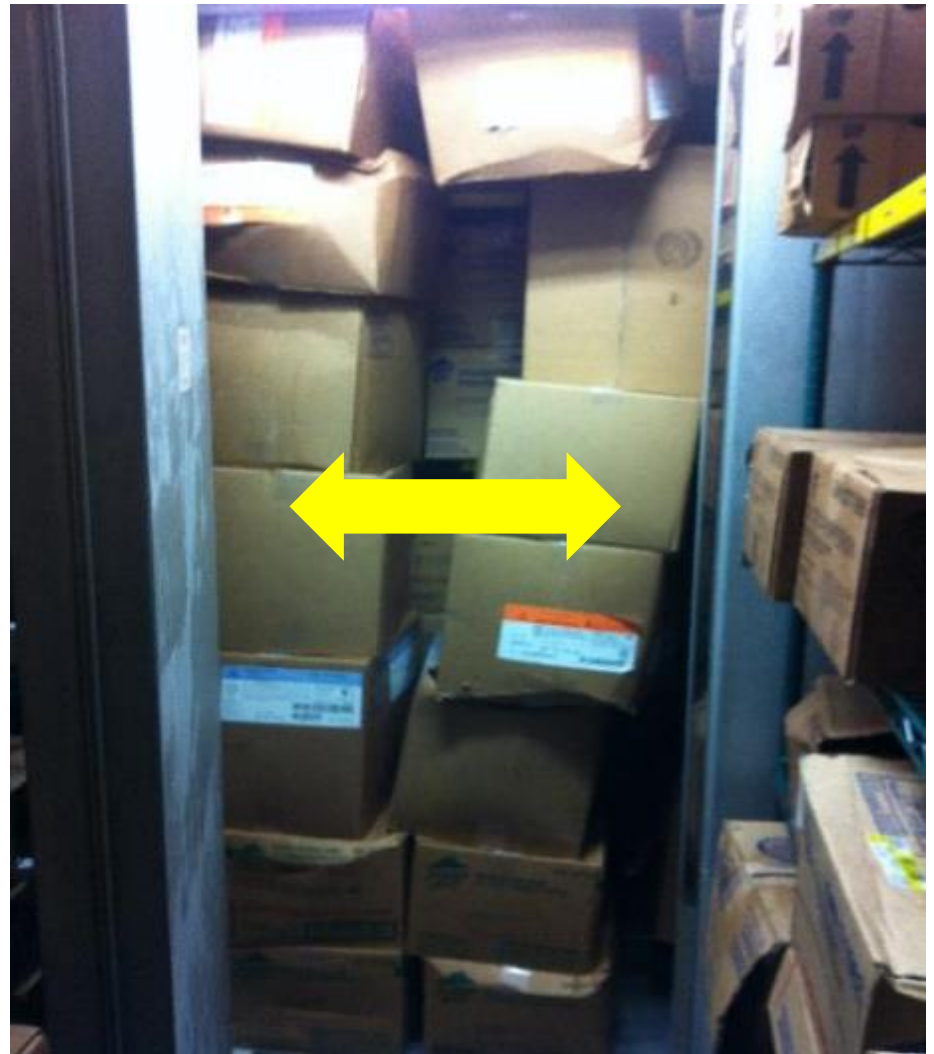
End User

- Door propped open
